Minimizing Crack Propagation in Cracked PV Backsheets with Repair Coatings

Keywords: Photovoltaic backsheets, repair coatings, microcrack

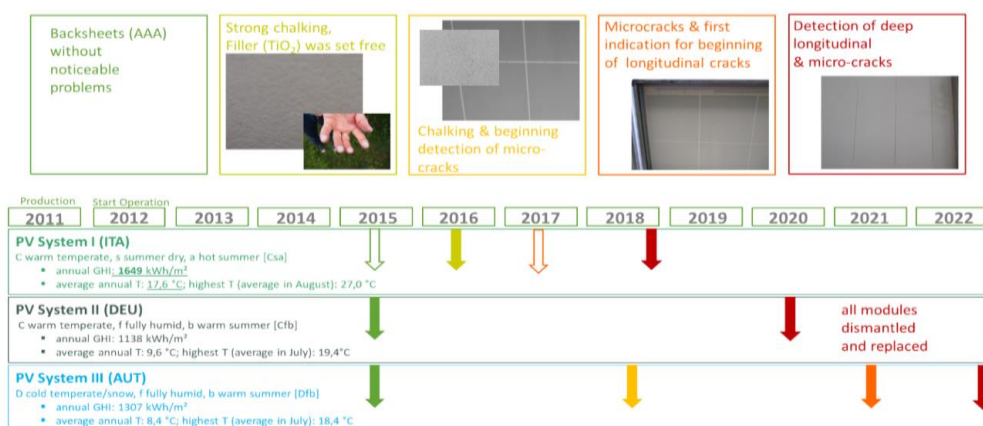
Figure 2: Timeline of chalking and crack-formation with PA-backsheets (AAA)

As can be seen from the timeline depicted in fig.2, chalking often is the first obvious sign for the beginning material degradation. Dependent on the climatic conditions, microcracks are detectable after 4-7 years operational time. Deep longitudinal cracks are then formed after another 2-4 years. This type of cracks will impose a safety risk due to failing wet leakage insulation and accelerate various PV module degradation modes by providing gateways of moisture ingress into the modules. As this can result in a performance loss over time and/or need for replacement of the modules. Thus, the development of reliable repair solutions – preferably to be applied on the microcracked backsheets - to prolong the operating life time and consequently the sustainability of the PV plant is an important task. Furthermore, a cost advantage / financial benefit for the owner can be achieved

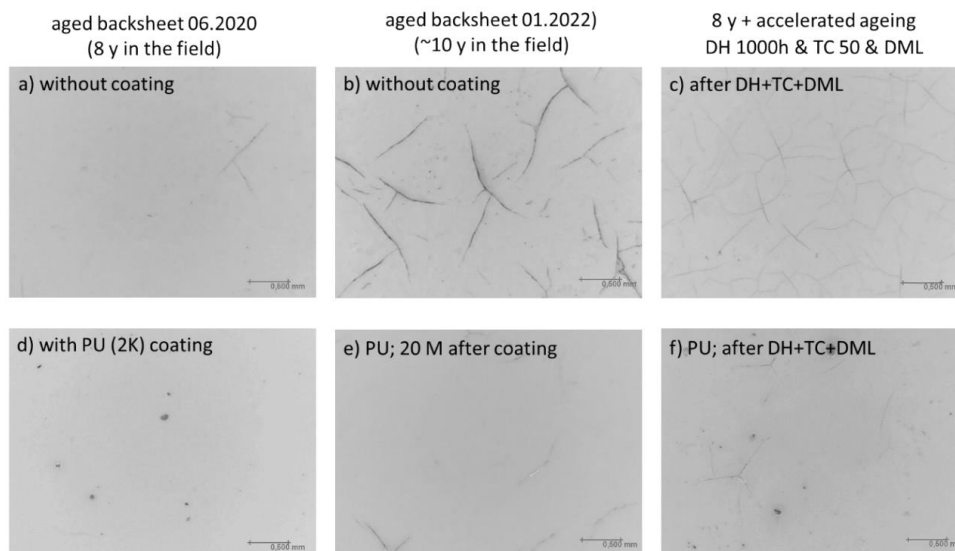
In fig. 3 a-c, the microscopic pictures of the BS surface of an uncoated module are depicted after 8 years in the field, after nearly 10 years in the field and after accelerated ageing. For this special case in Carinthia, after 8 years in the field, the first microcracks were detected with the USB-microscope, 20 months later, a much higher density of surface cracks was detected. For comparison, the microscopic images of the PU-coated modules (fig. 3 d-f) directly after coating, after 20 months in the field (= natural weathering) and after accelerated ageing are summarized.

Figure 3: microscopic images of the uncoated (upper row) and PU-coated (lower row) backsheet

The evaluation of crack propagation of the repaired modules coated in the field showed that uncoated >> epoxy > synth. rubber ~ silicone > PU. The same trend was observed after accelerated ageing. The chemical stability of the coatings was also investigated (by FTIR spectroscopy) and showed chemical degradation for the epoxide coating (see fig.4), but stable IR-absorption for silicone and PU. The adhesion of the coating to the weathered BS was good after coating, after 20 months of natural weathering and after accelerated ageing.

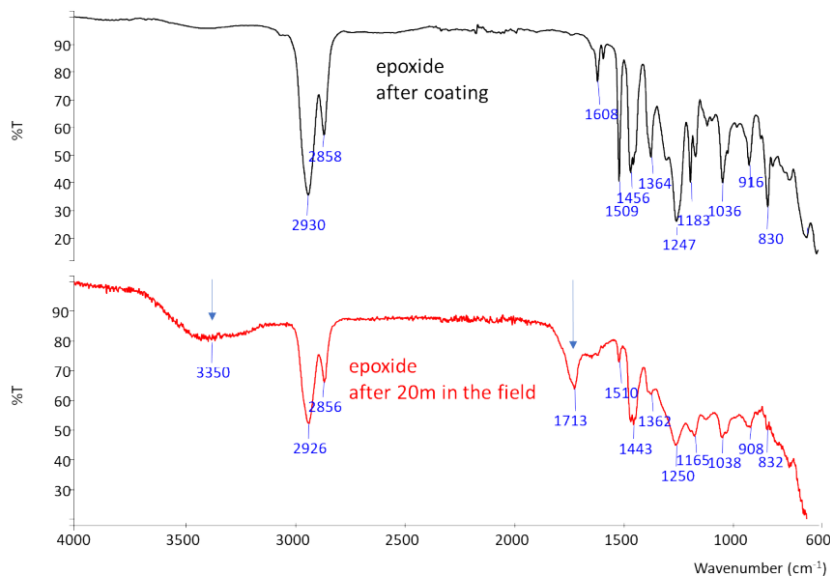
Figure 4: FTIR spectra of the epoxide coating directly after coating and after 20 months natural weathering
